UNITED STATES ENVIRONMENTAL PROTECTION AGENCY

INSTALLATION NAME: Arcelor Mittal Burns Harbor, LLC

DATE OF RCRA INSPECTION: June 13, 14, 15, 20, 27 - 30, 2011

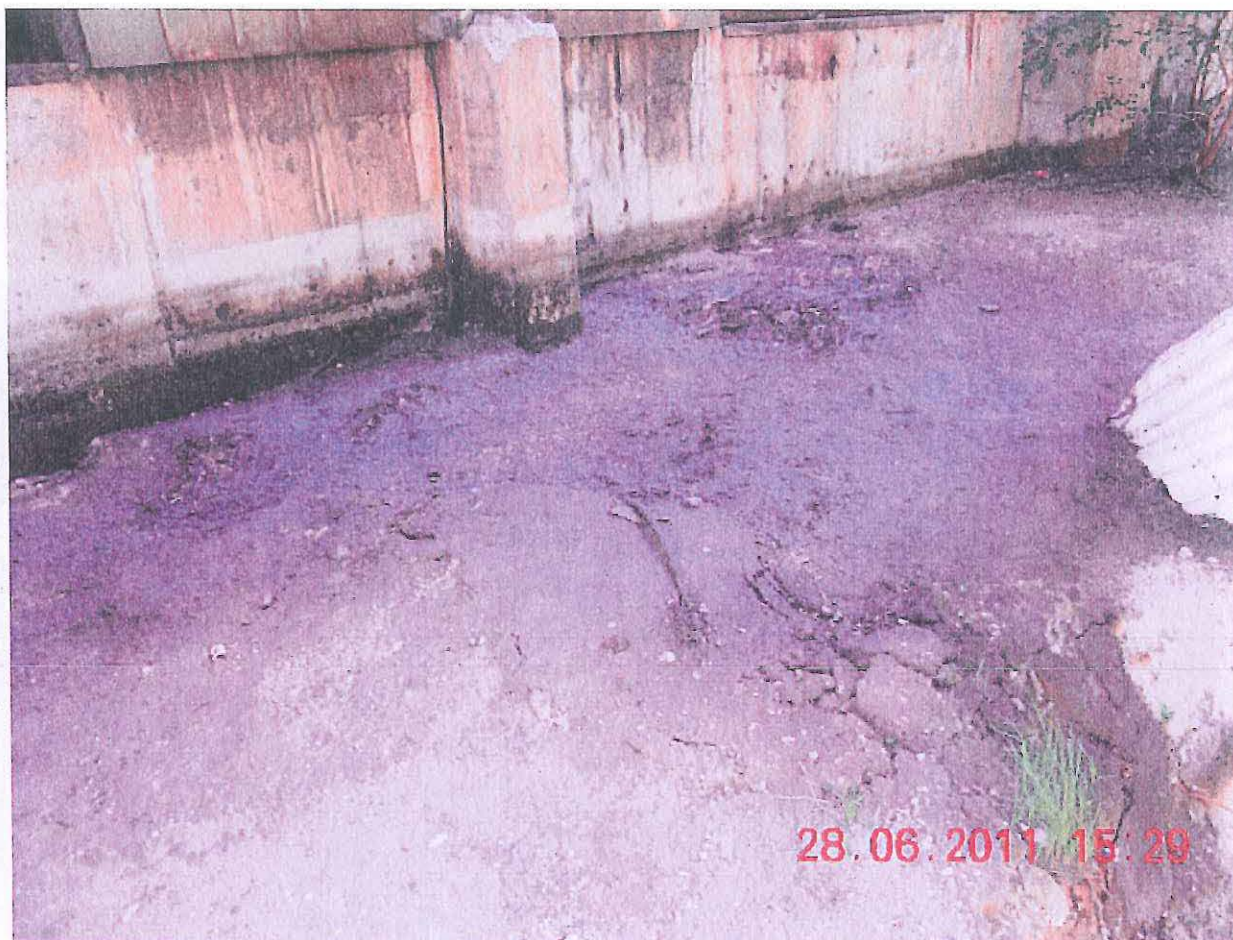
Facility: Arcelor Mittal, IND003913423
Location: 250 West US Highway 12, Burns Harbor, Indiana
Date: June 28, 2011, 3:27 p.m.
Photographer: Robert Dean Smith, LPG
Camera: Nikon Coolpix, 12.0 megapixels
Description: Photograph 41: DIW Sewer manhole area, near spent pickle liquor tank. Facing S.

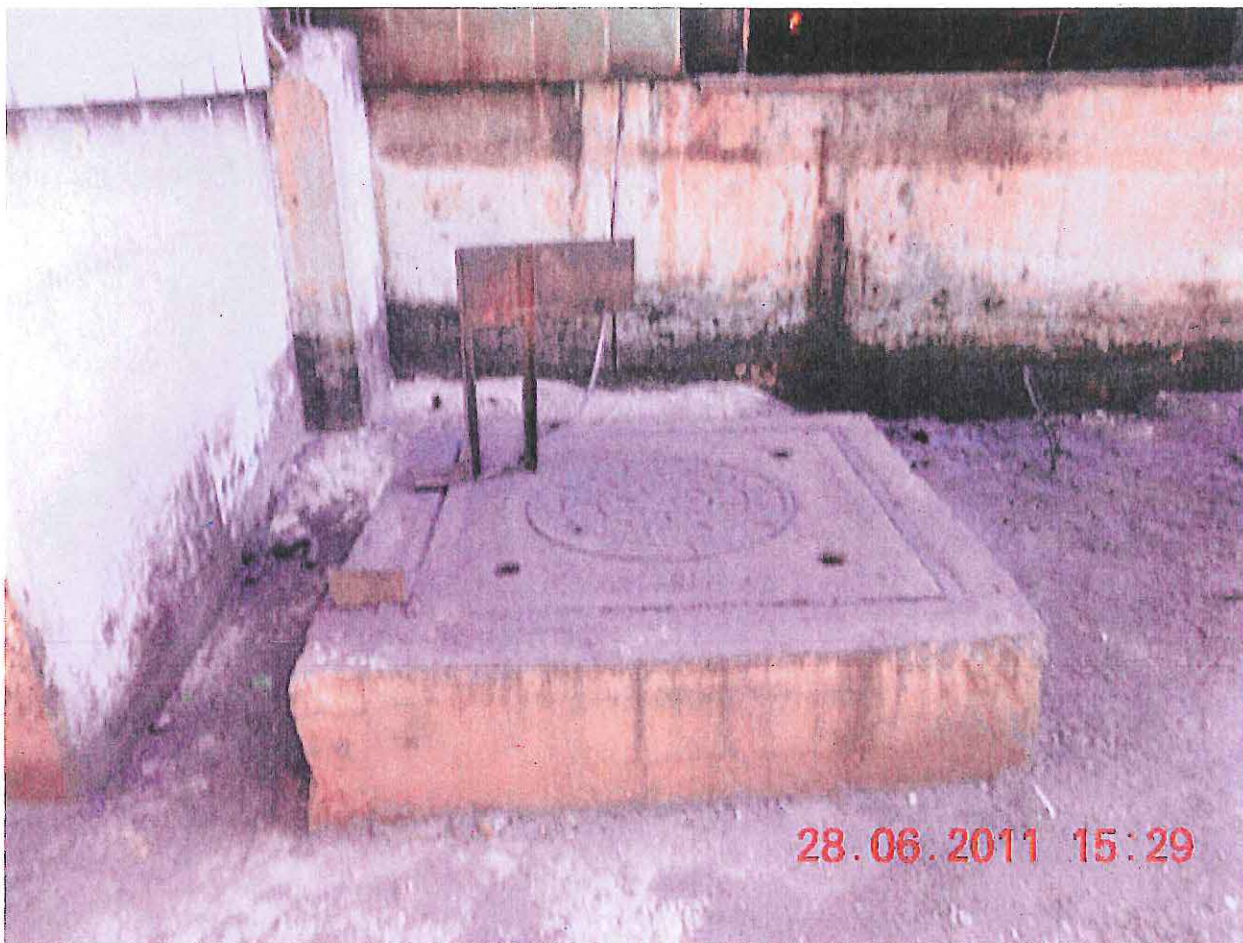
Facility: Arcelor Mittal, IND003913423
Location: 250 West US Highway 12, Burns Harbor, Indiana
Date: June 28, 2011, 3:29 p.m.
Photographer: Robert Dean Smith, LPG
Camera: Nikon Coolpix, 12.0 megapixels
Description: Photograph 42: DIW Sewer manhole area, near spent pickle liquor tank. Facing S.

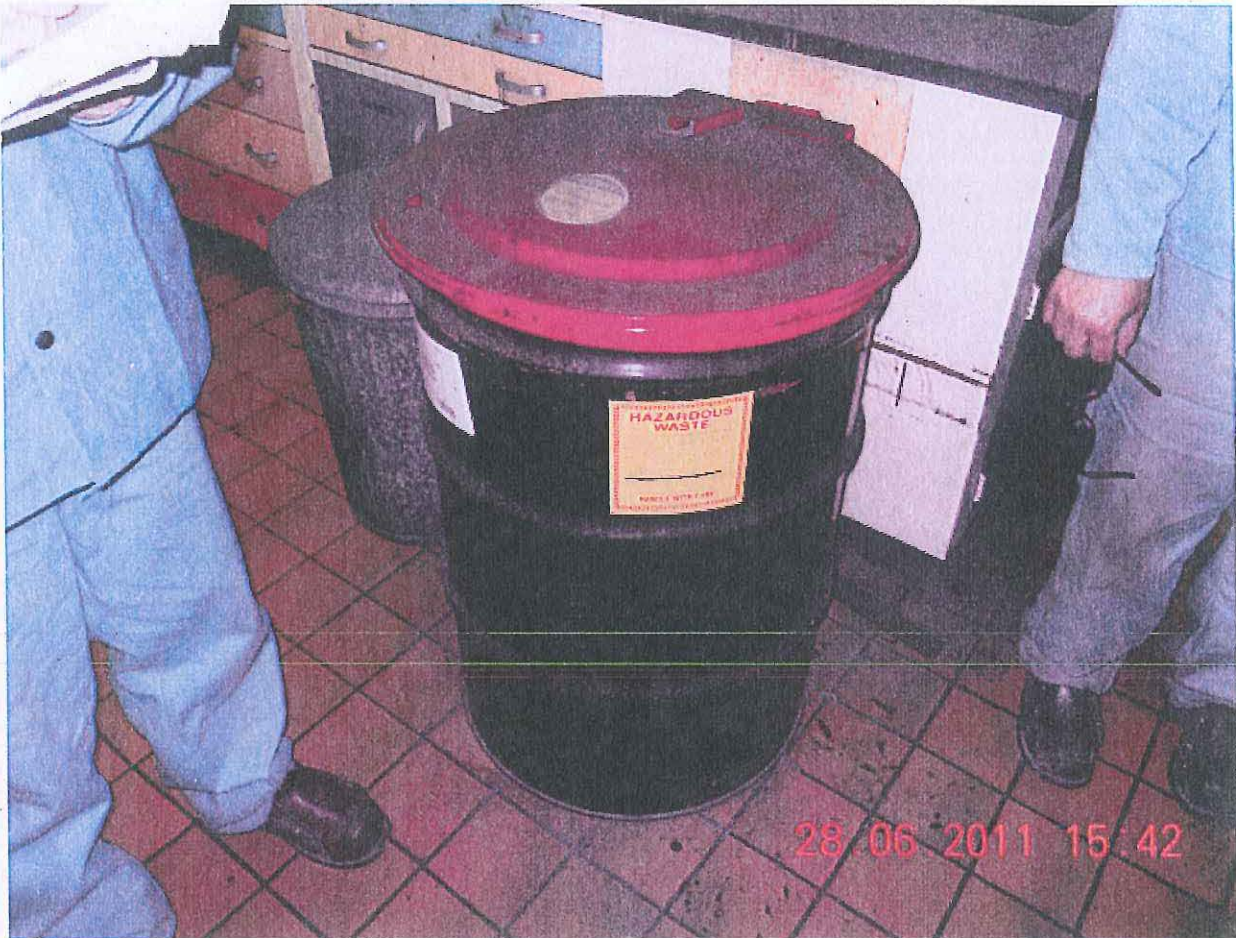
Facility: Arcelor Mittal, IND003913423
Location: 250 West US Highway 12, Burns Harbor, Indiana
Date: June 28, 2011, 3:42 p.m.
Photographer: Robert Dean Smith, LPG
Camera: Nikon Coolpix, 12.0 megapixels
Description: Photograph 44: Laboratory waste, F003/F005, rags. The 55-gallon drum is properly labeled, stored closed, and properly marked. Satellite accumulation.

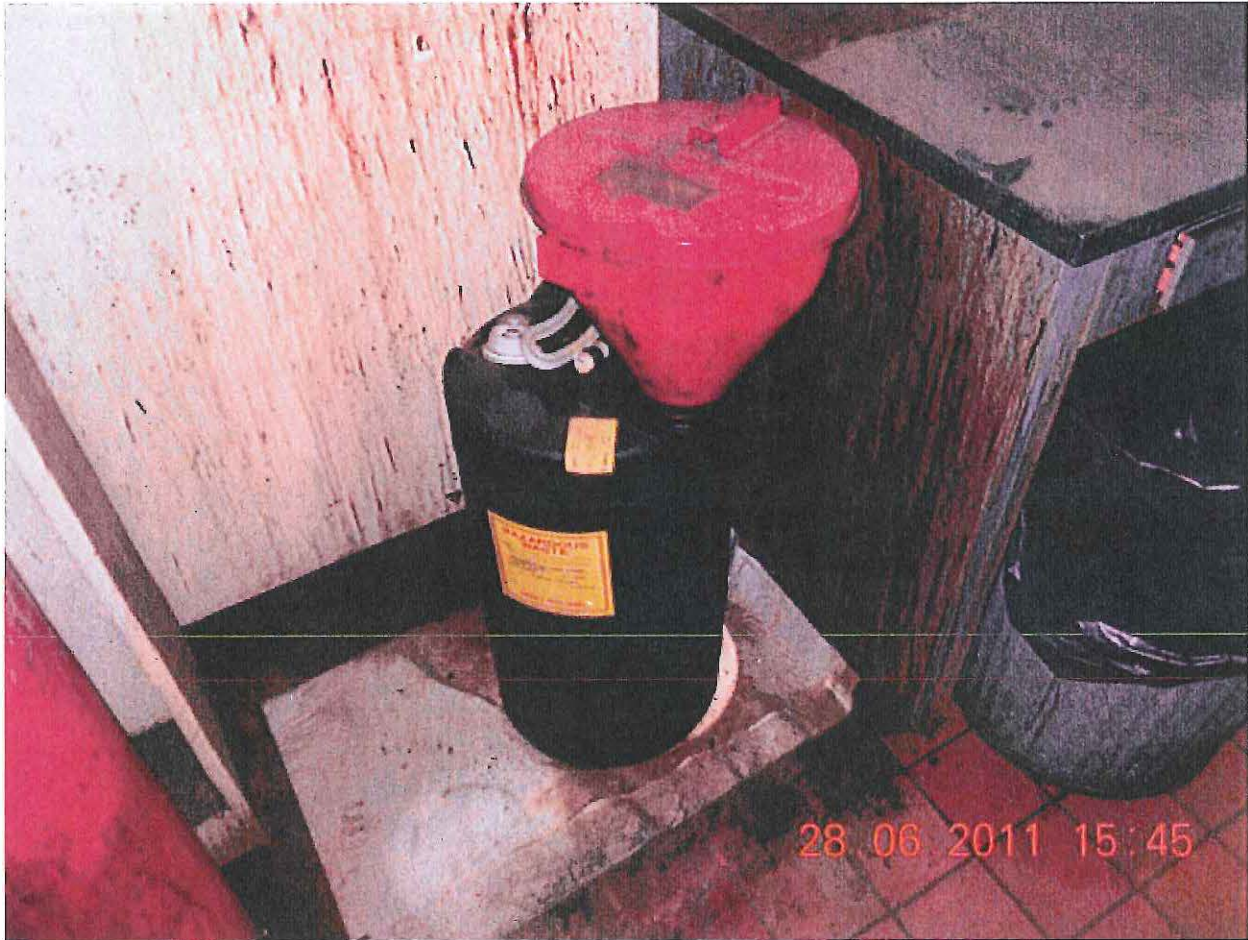
Facility: Arcelor Mittal, IND003913423
Location: 250 West US Highway 12, Burns Harbor, Indiana
Date: June 28, 2011, 3:45 p.m.
Photographer: Robert Dean Smith, LPG
Camera: Nikon Coolpix, 12.0 megapixels
Description: Photograph 45: Used oil at laboratory. The waste oil is properly labeled and managed.

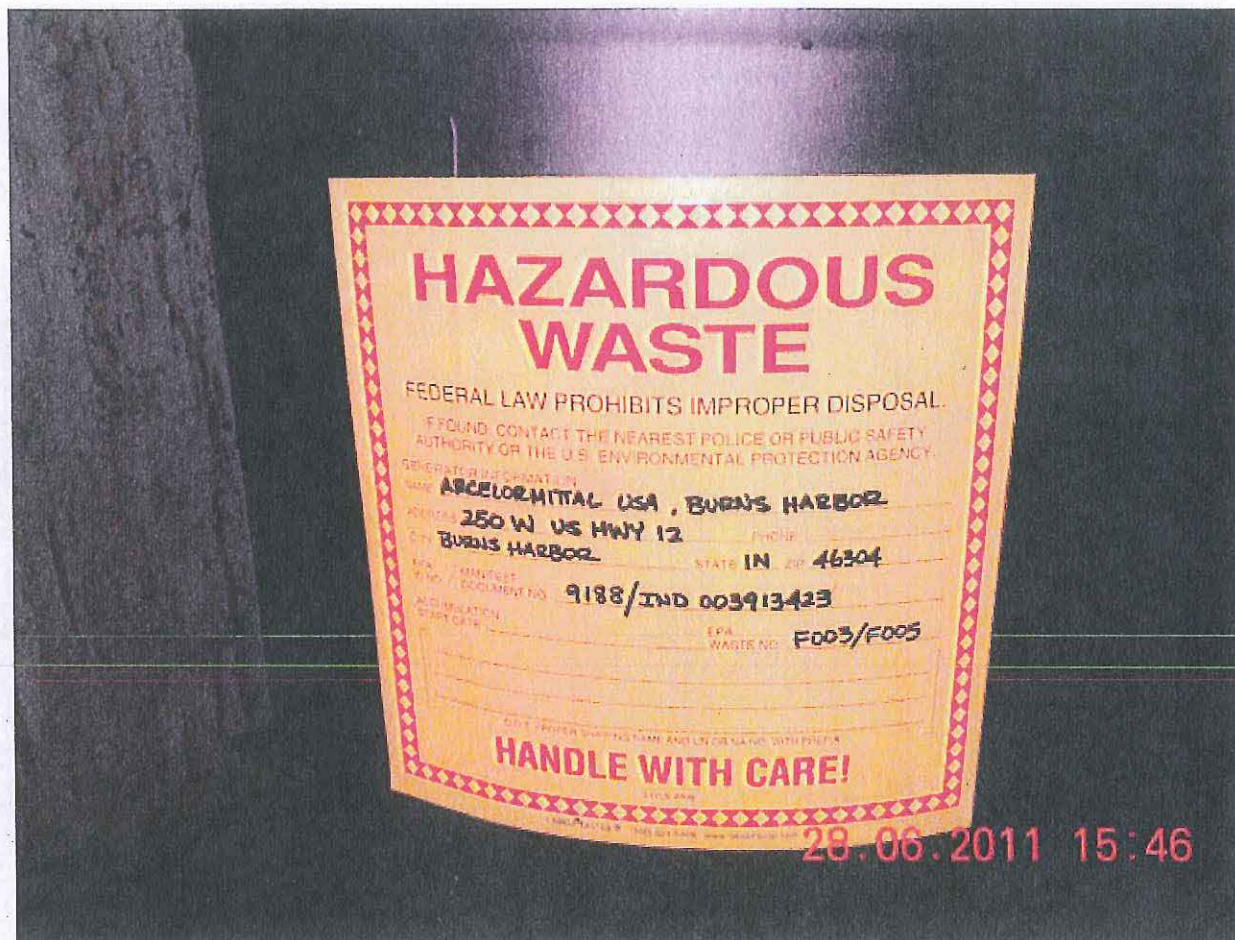
Facility: Arcelor Mittal, IND003913423
Location: 250 West US Highway 12, Burns Harbor, Indiana
Date: June 28, 2011, 3:46 p.m.
Photographer: Robert Dean Smith, LPG
Camera: Nikon Coolpix, 12.0 megapixels
Description: Photograph 46: Label for the F003/F005 drum within the laboratory.

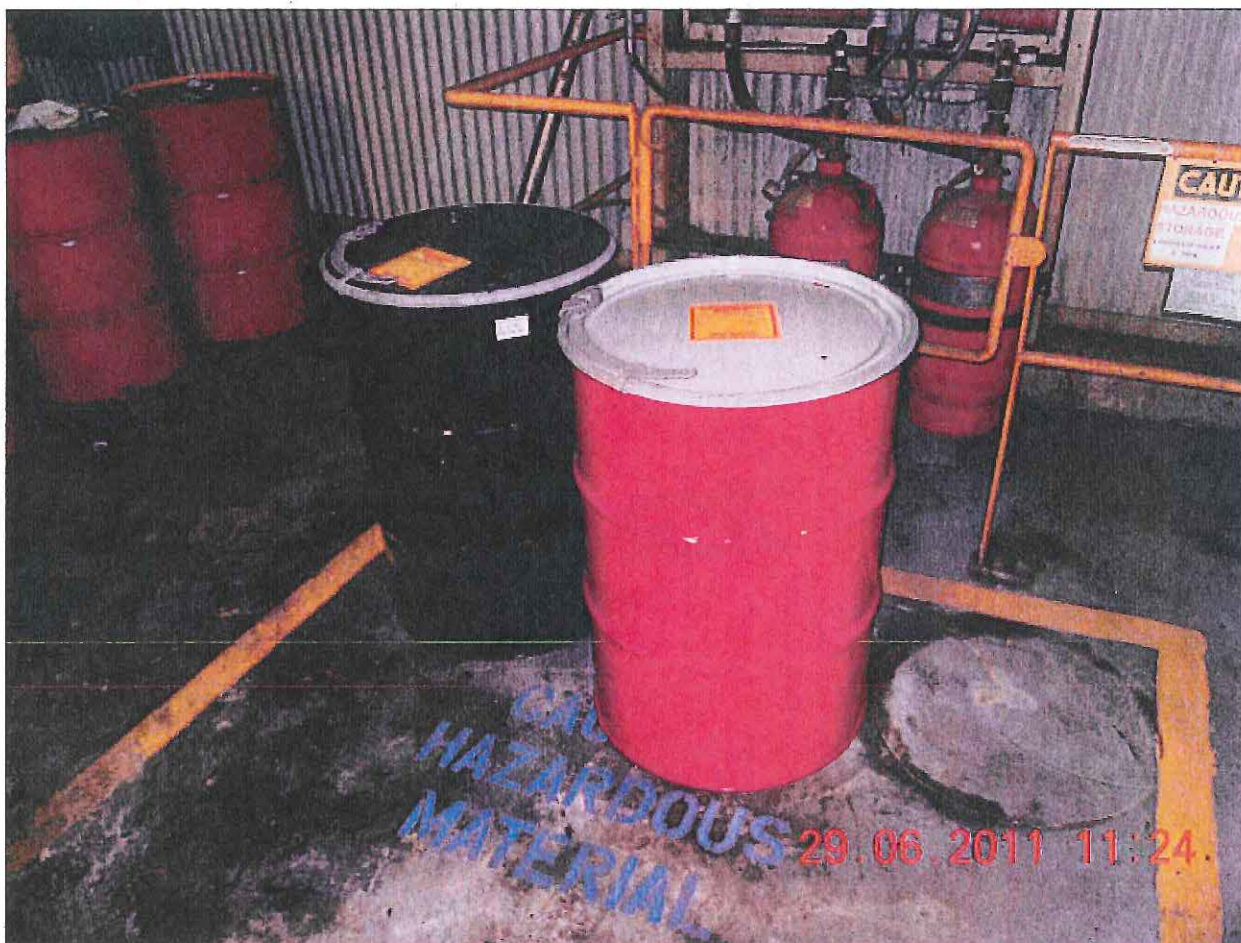
- Inspector Smith observed and photographed a less than 90 day hazardous waste accumulation area within the galvanizing shop. Inspector Smith observed and photographed two drums of hazardous waste that were properly managed, labeled, and stored closed. Both drums were dated 6/18/11 (photograph 47).

Facility: Arcelor Mittal, IND003913423
Location: 250 West US Highway 12, Burns Harbor, Indiana
Date: June 29, 2011, 11:24 a.m.
Photographer: Robert Dean Smith, LPG
Camera: Nikon Coolpix, 12.0 megapixels
Description: Photograph 47: Less than 90 day hazardous waste accumulation area at the hot dip galvanizing shop. The hazardous waste is properly managed, labeled, and stored closed. The drum on the left is chrome phosphate, dated 6/18/11. Drum on right is chrome and phosphate waste. Dated 6/18/11.

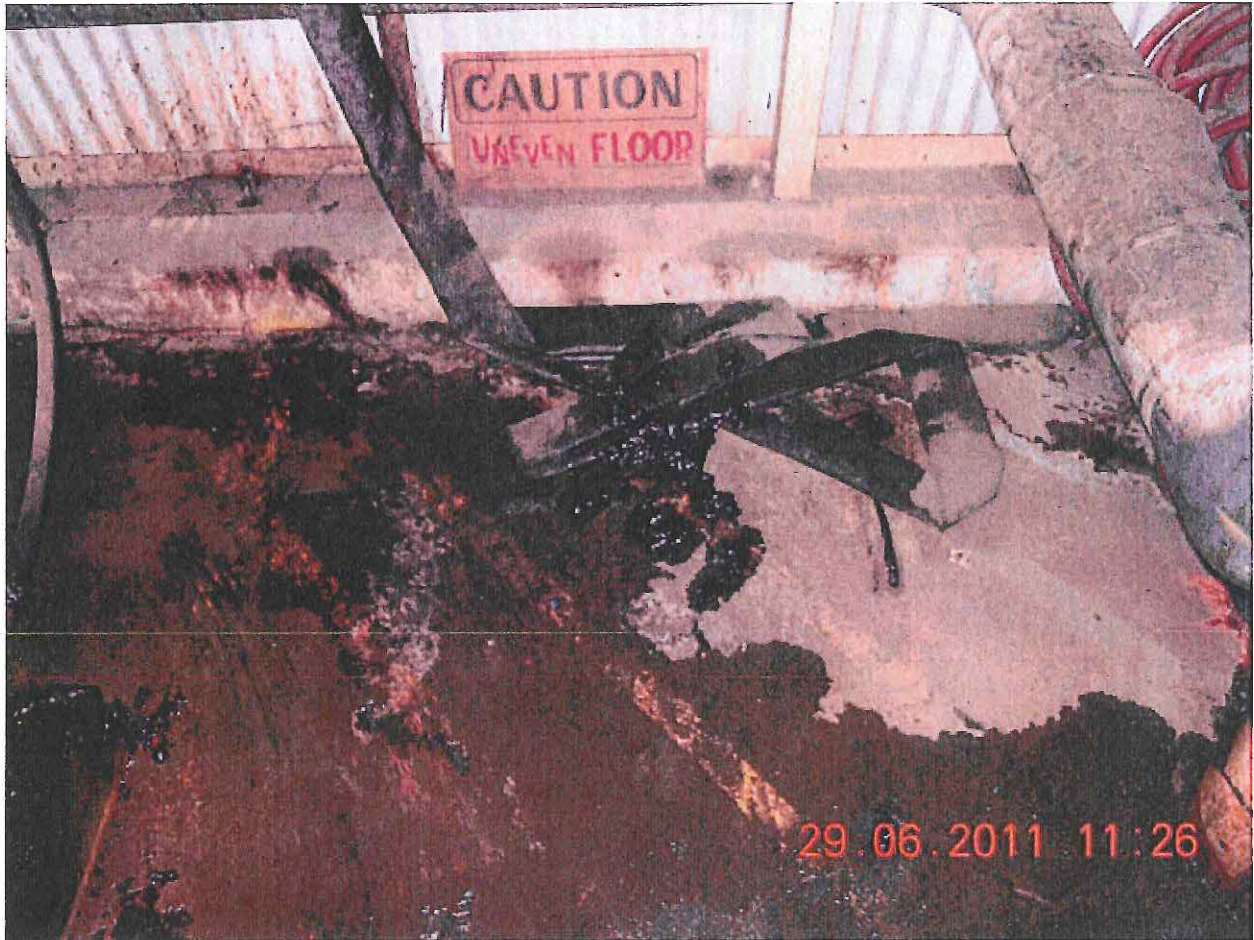
- Inspector Smith observed and photographed an area adjacent to the less than 90 day hazardous waste storage area that had water and grease on the floor (photographs 48 and 49).

Facility: Arcelor Mittal, IND003913423
Location: 250 West US Highway 12, Burns Harbor, Indiana
Date: June 29, 2011, 11:26 a.m.
Photographer: Robert Dean Smith, LPG
Camera: Nikon Coolpix, 12.0 megapixels
Description: Photograph 49: Close-up of the grease on the floor near the less than 90 day hazardous waste accumulation area, galvanizing shop. Facing S.

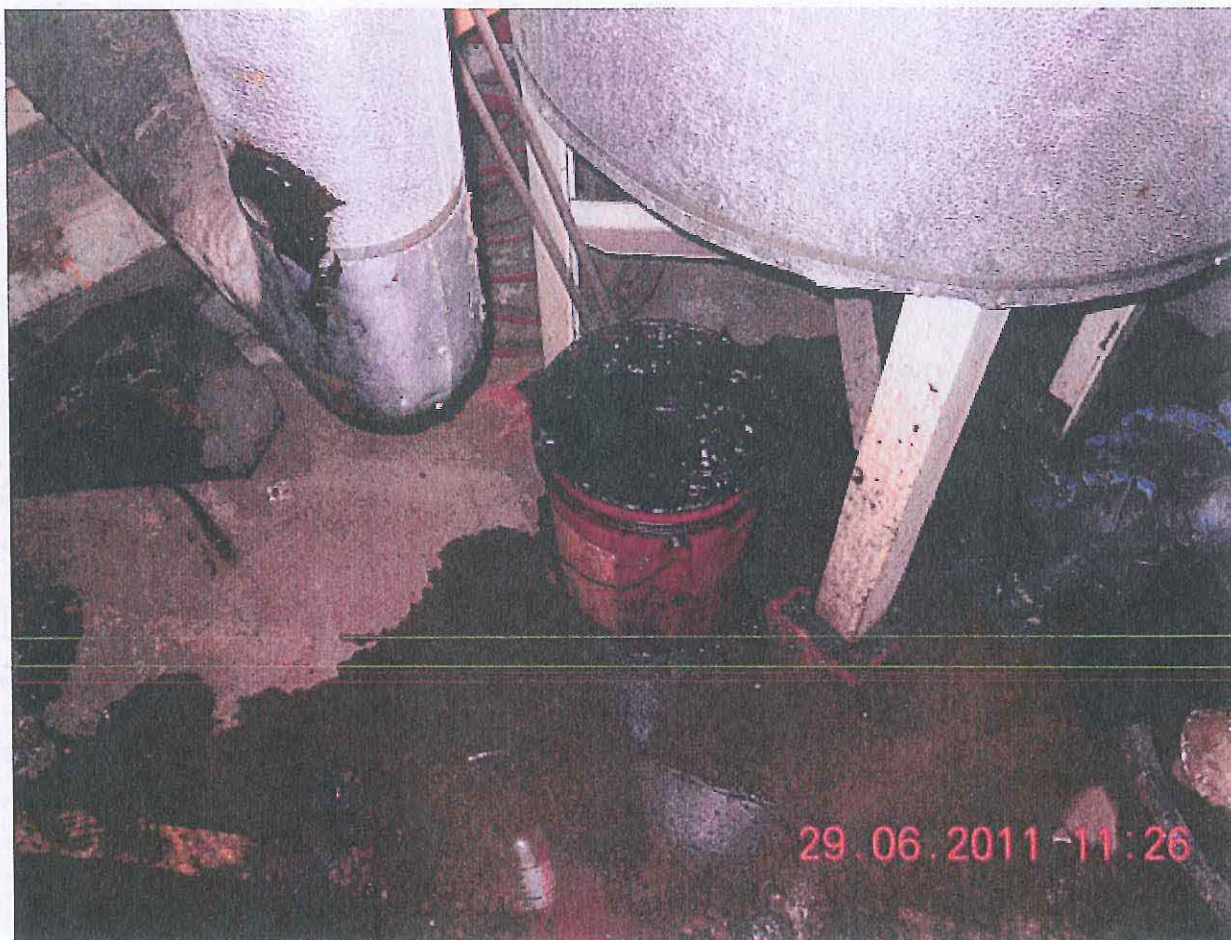
- Inspector Smith observed and photographed a grease bucket in an area adjacent to the less than 90 day hazardous waste accumulation area (photograph 50).

Facility: Arcelor Mittal, IND003913423
Location: 250 West US Highway 12, Burns Harbor, Indiana
Date: June 29, 2011, 11:26 a.m.
Photographer: Robert Dean Smith, LPG
Camera: Nikon Coolpix, 12.0 megapixels
Description: Photograph 50: Grease bucket in storage near the less than 90 day hazardous waste accumulation area, galvanizing shop. Facing E.

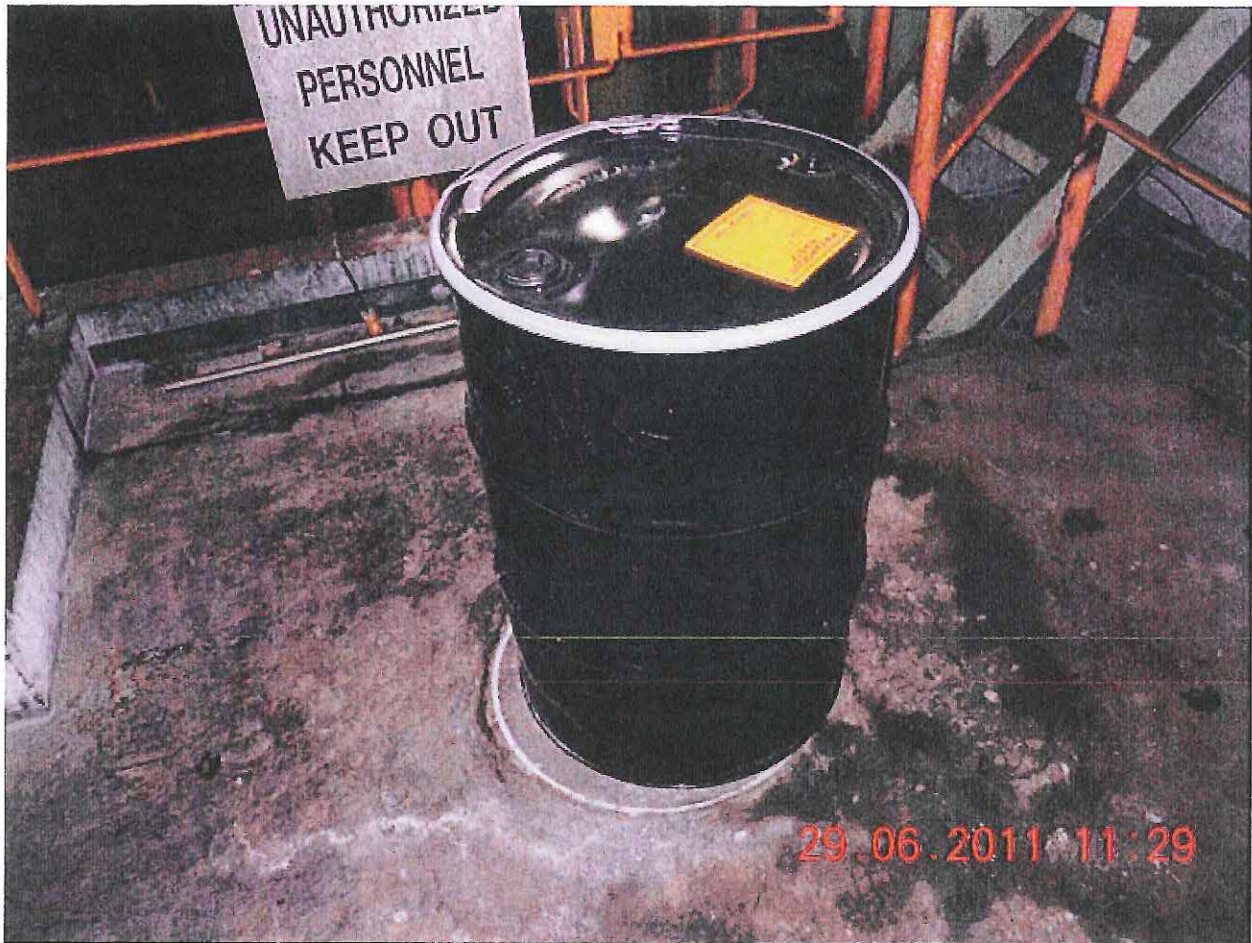
Facility: Arcelor Mittal, IND003913423
Location: 250 West US Highway 12, Burns Harbor, Indiana
Date: June 29, 2011, 11:29 a.m.
Photographer: Robert Dean Smith, LPG
Camera: Nikon Coolpix, 12.0 megapixels
Description: Photograph 51: Satellite accumulation, waste filters, marked chromate, phosphate absorbent materials.

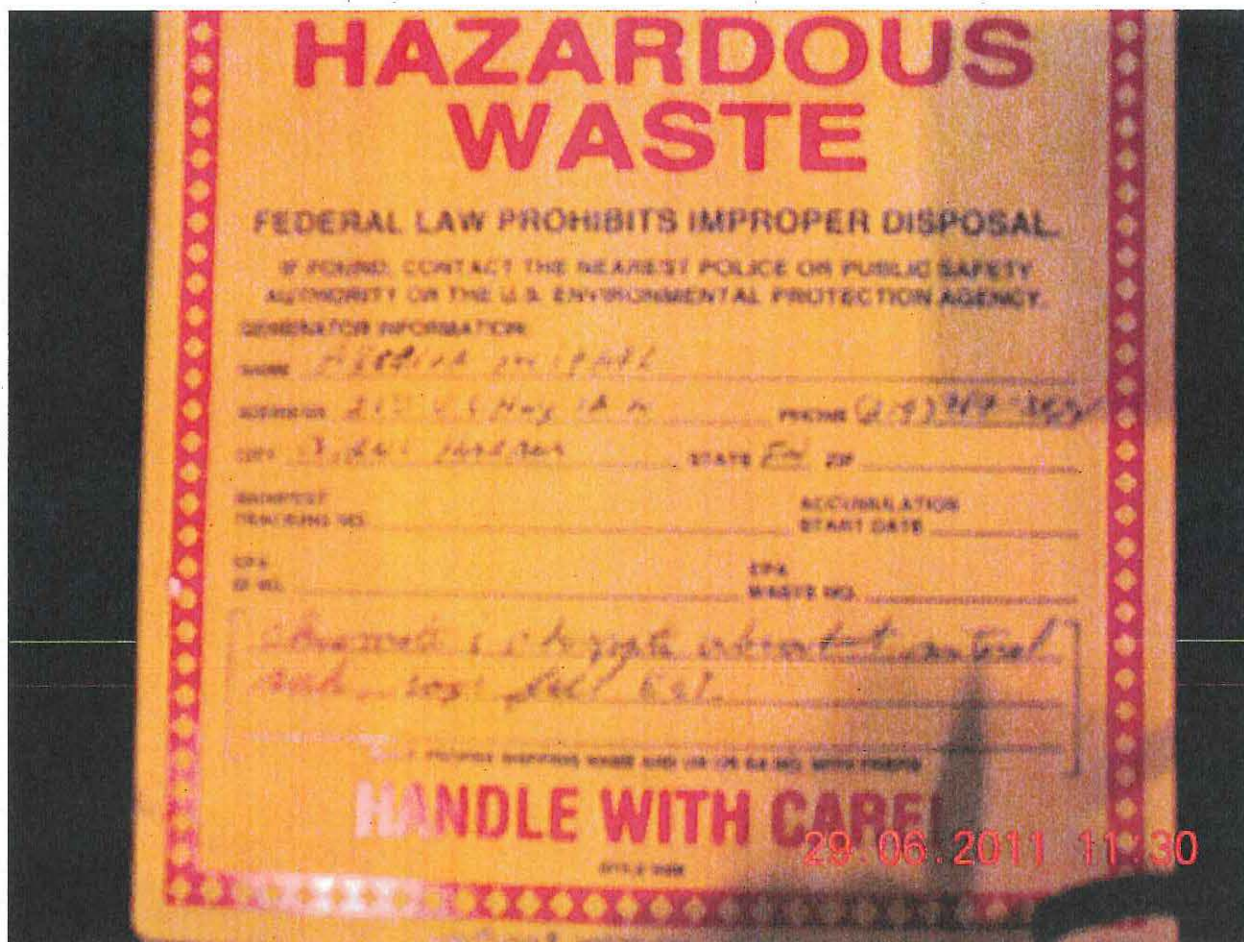
- Inspector Smith observed and photographed a satellite accumulation area in which a 55-gallon drum of waste filters was accumulating. The drum was labeled "chromate, phosphate absorbent materials" and was stored closed (photograph 51). I photographed the label of the 55-gallon drum to show there was no date of accumulation (photographs 52 and 53).

Facility:	Arcelor Mittal, IND003913423
Location:	250 West US Highway 12, Burns Harbor, Indiana
Date:	June 29, 2011, 11:30 a.m.
Photographer:	Robert Dean Smith, LPG
Camera:	Nikon Coolpix, 12.0 megapixels
Description:	Photograph 53: Label for the chromate & phosphate absorbent material.

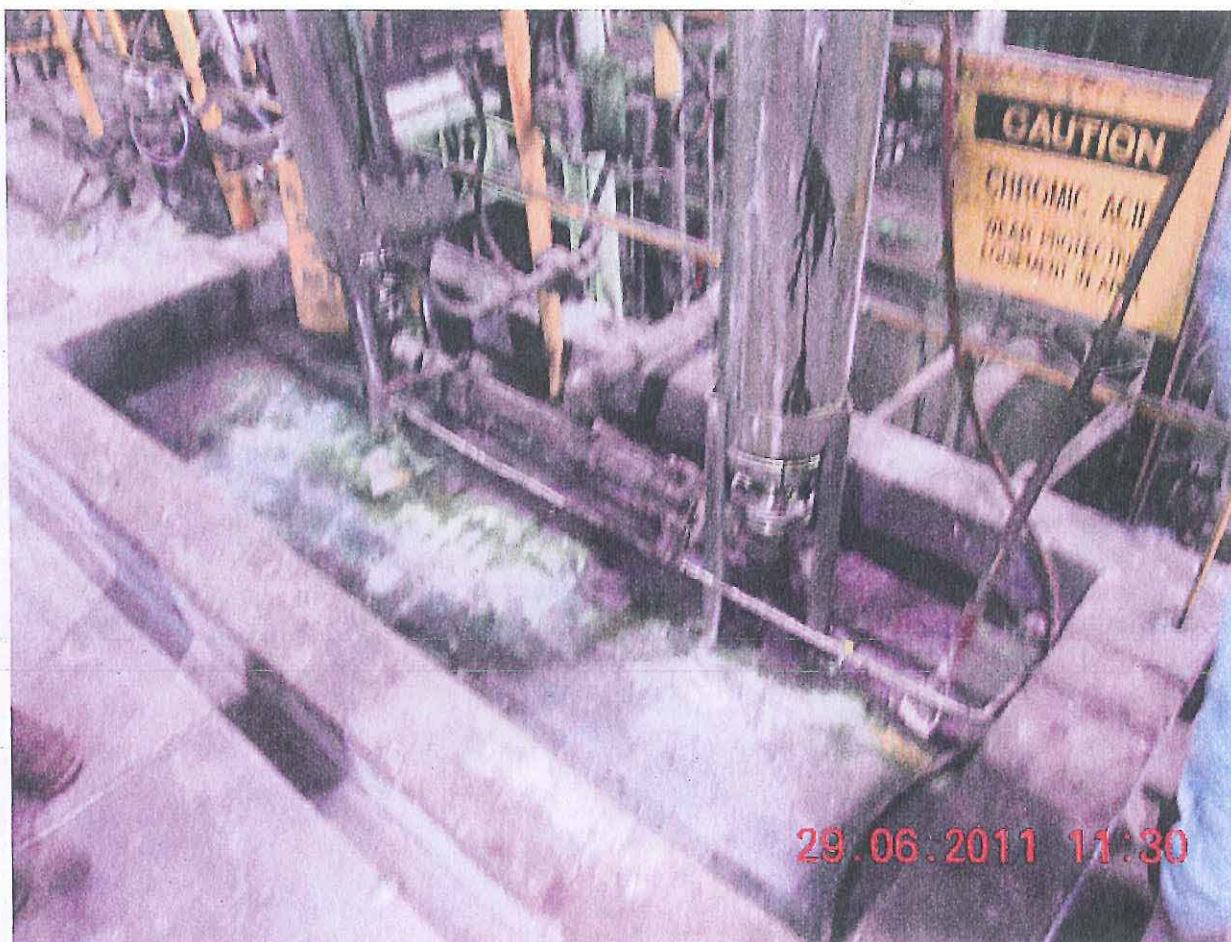
- Inspector Smith observed and photographed the area in which waste chromic acid is generated. The area has a pipe in which the waste acid is removed from the system and secondary containment is in place below the piping. Waste chromic acid residue was observed in the secondary containment (photograph 54, 55 and 56).

Facility: Arcelor Mittal, IND003913423
Location: 250 West US Highway 12, Burns Harbor, Indiana
Date: June 29, 2011, 11:30 a.m.
Photographer: Robert Dean Smith, LPG
Camera: Nikon Coolpix, 12.0 megapixels
Description: Photograph 54: Area where Chromic acid waste is generated. Blurry photograph due to the flash malfunctioning.

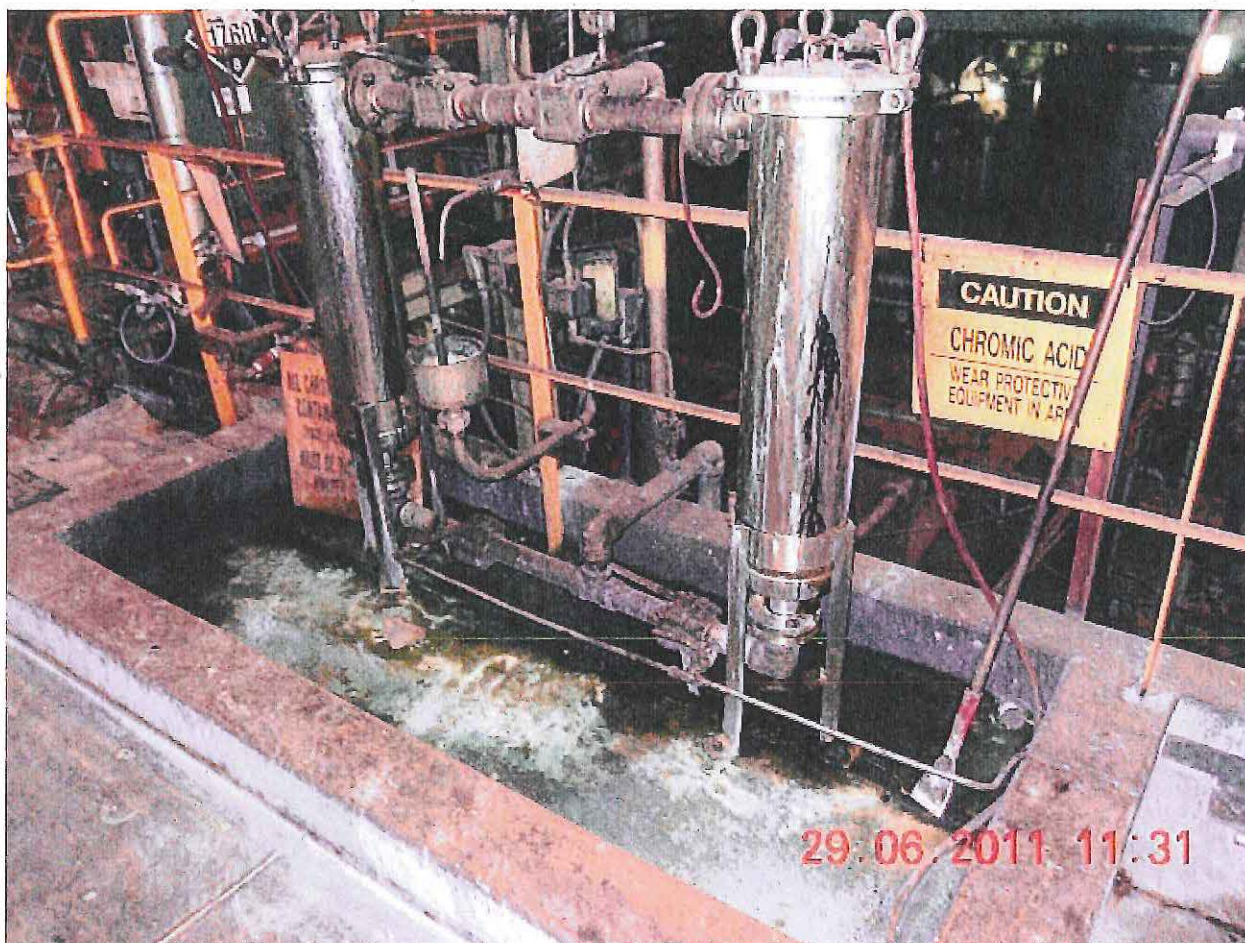
Facility: Arcelor Mittal, IND003913423
Location: 250 West US Highway 12, Burns Harbor, Indiana
Date: June 29, 2011, 11:31 a.m.
Photographer: Robert Dean Smith, LPG
Camera: Nikon Coolpix, 12.0 megapixels
Description: Photograph 55: Area where Chromic acid waste is generated.

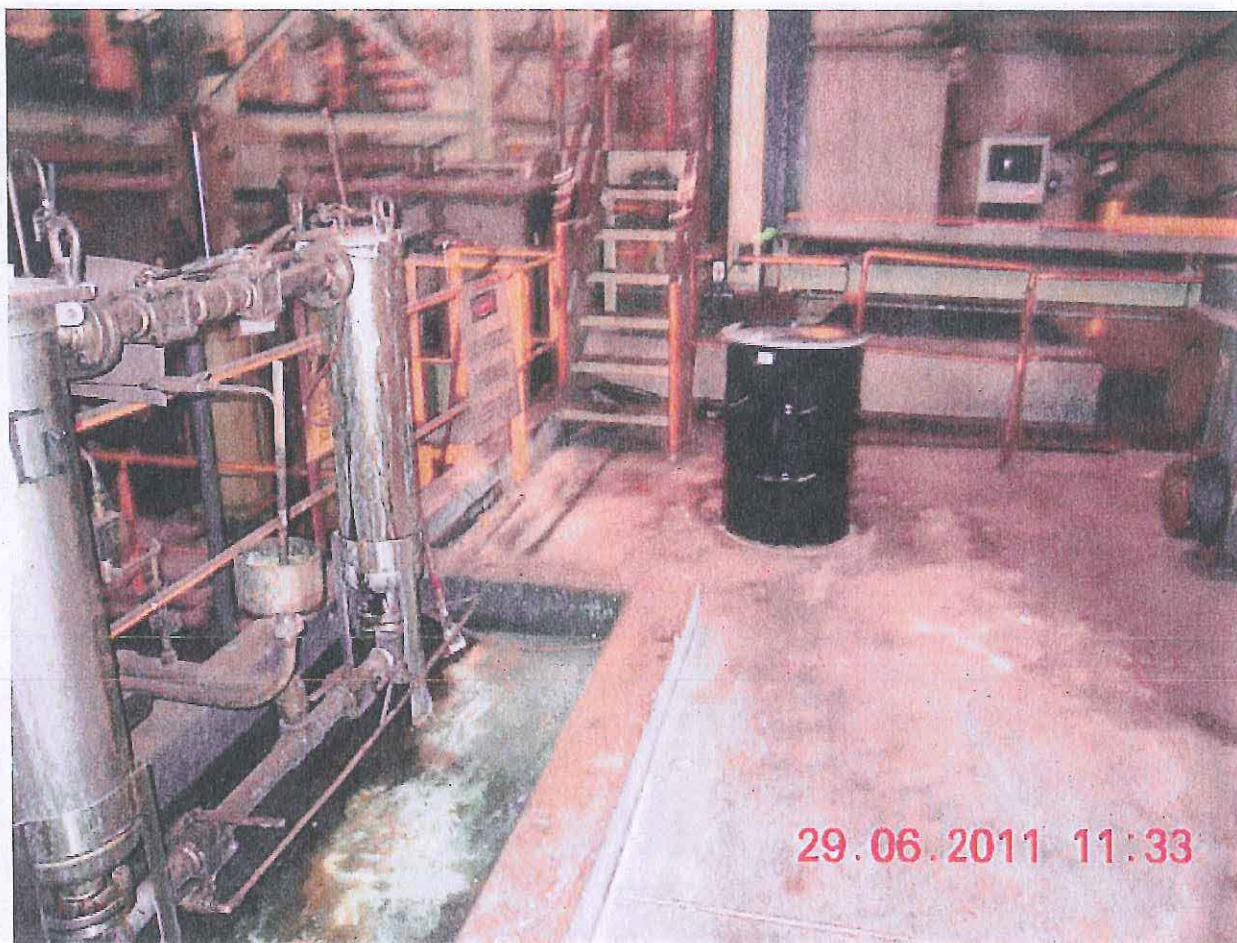
Facility: Arcelor Mittal, IND003913423
Location: 250 West US Highway 12, Burns Harbor, Indiana
Date: June 29, 2011, 11:33 a.m.
Photographer: Robert Dean Smith, LPG
Camera: Nikon Coolpix, 12.0 megapixels
Description: Photograph 56: Area where Chromic acid waste is generated. The drum in the background is the same SAA drum shown in Photo 51.

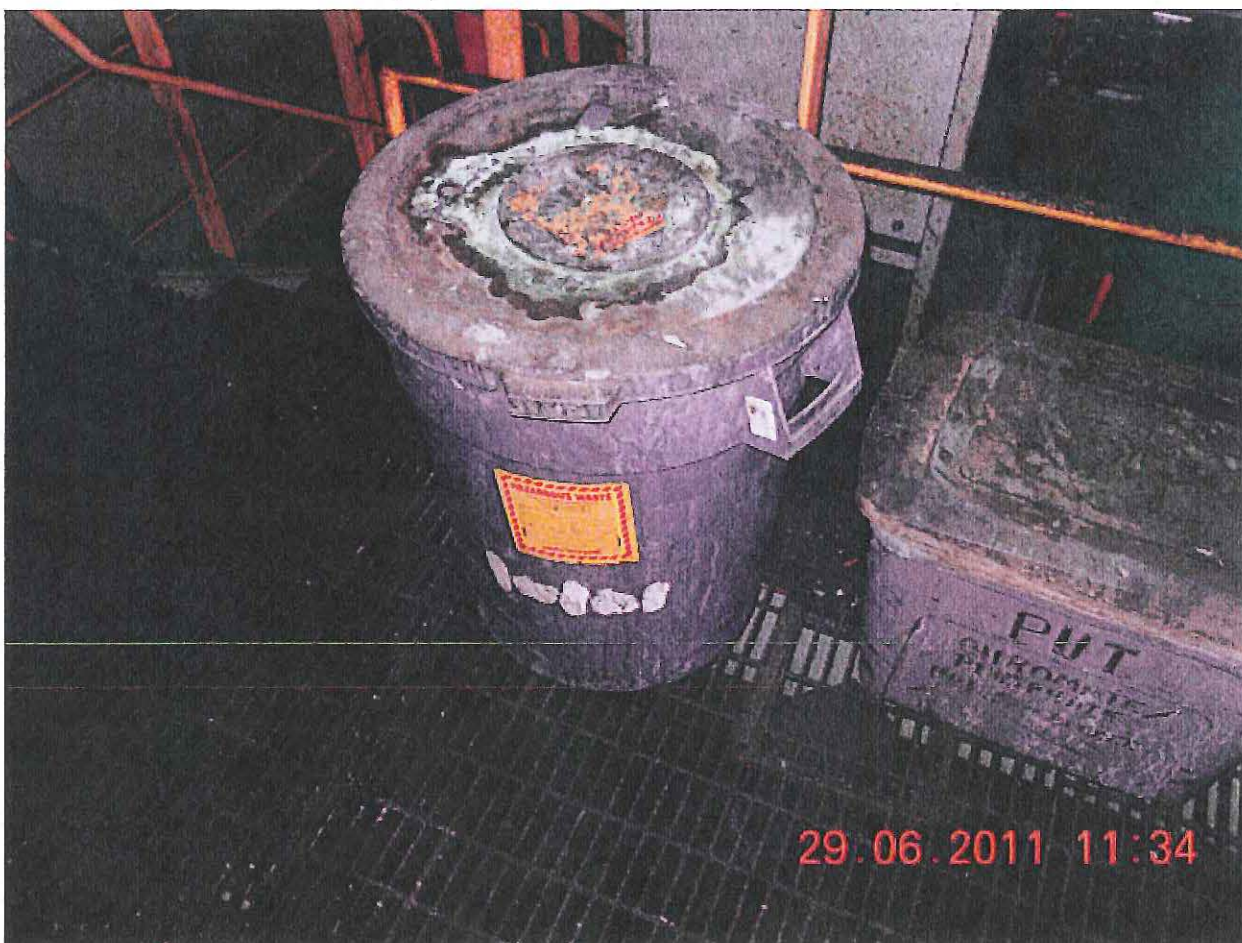
- Inspector Smith observed and photographed a satellite accumulation container, a grey plastic 5-gallon bucket. The bucket was closed, had a hazardous waste sticker affixed and was dated 5/5/11 even though satellite accumulation containers do not need a date of accumulation (photograph 57 and 58).
- Inspector Smith observed and photographed the sub basement for the phosphating area. The sub basement had evidence of spilled chromic acid (photographs 59 - 61).
- Inspector Smith observed and photographed the hose where chromic acid is loaded onto tanker trucks for transport off-site disposal or treatment. The hose is located on the west side of the building and is accessed through a double door. The hose is coiled and is uncoiled to hook up to the tanker truck. The area has an emergency shower, two concrete/steel bumpers, and emergency pump shut off switches (Photograph 62-66).

Facility: Arcelor Mittal, IND003913423
Location: 250 West US Highway 12, Burns Harbor, Indiana
Date: June 29, 2011, 11:34 a.m.
Photographer: Robert Dean Smith, LPG
Camera: Nikon Coolpix, 12.0 megapixels
Description: Photograph 57: Satellite accumulation, chromate, phosphate waste.

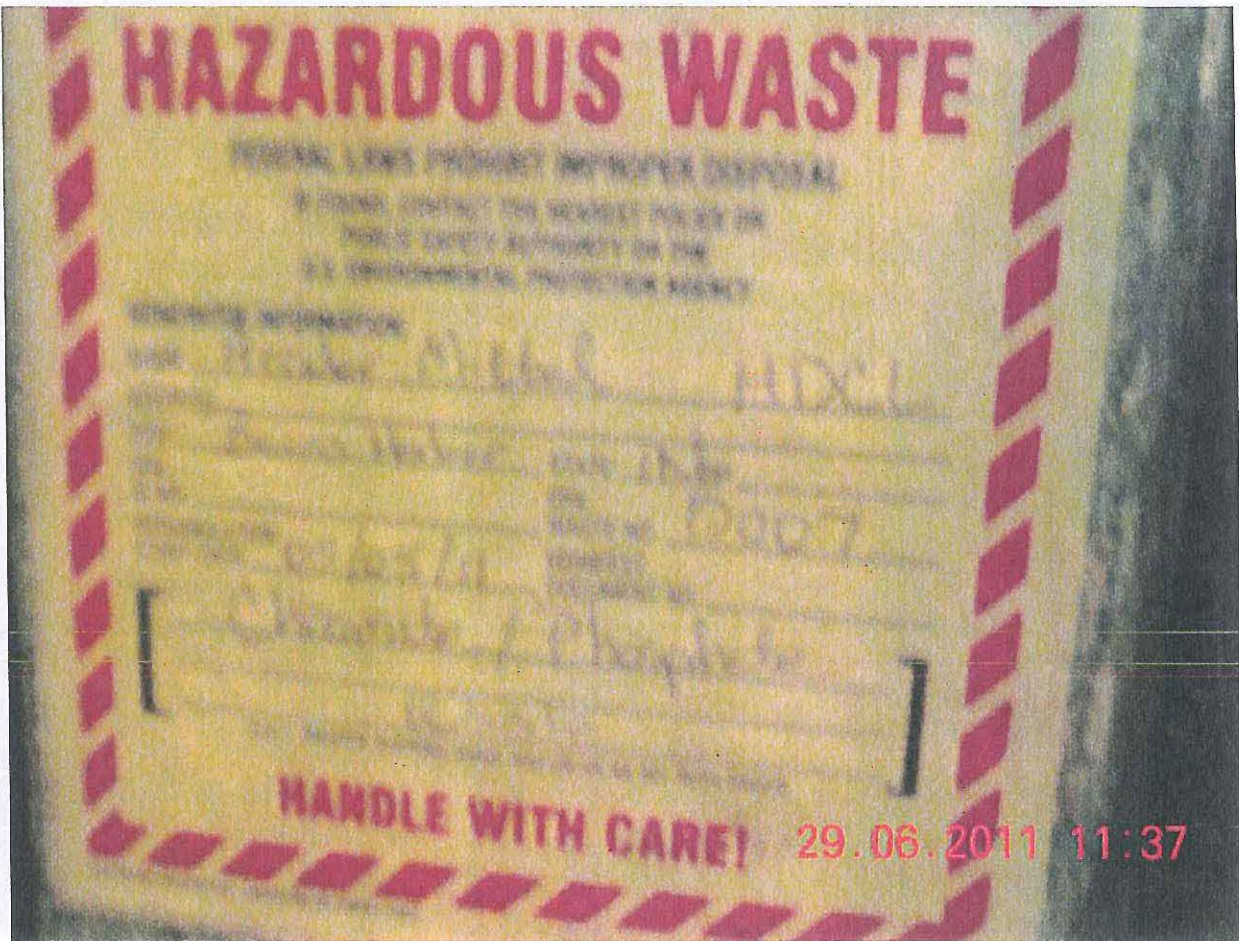
Facility: Arcelor Mittal, IND003913423
Location: 250 West US Highway 12, Burns Harbor, Indiana
Date: June 29, 2011; 11:37 a.m.
Photographer: Robert Dean Smith, LPG
Camera: Nikon Coolpix, 12.0 megapixels
Description: Photograph 58: Label for satellite accumulation container, chromate/phosphate waste.

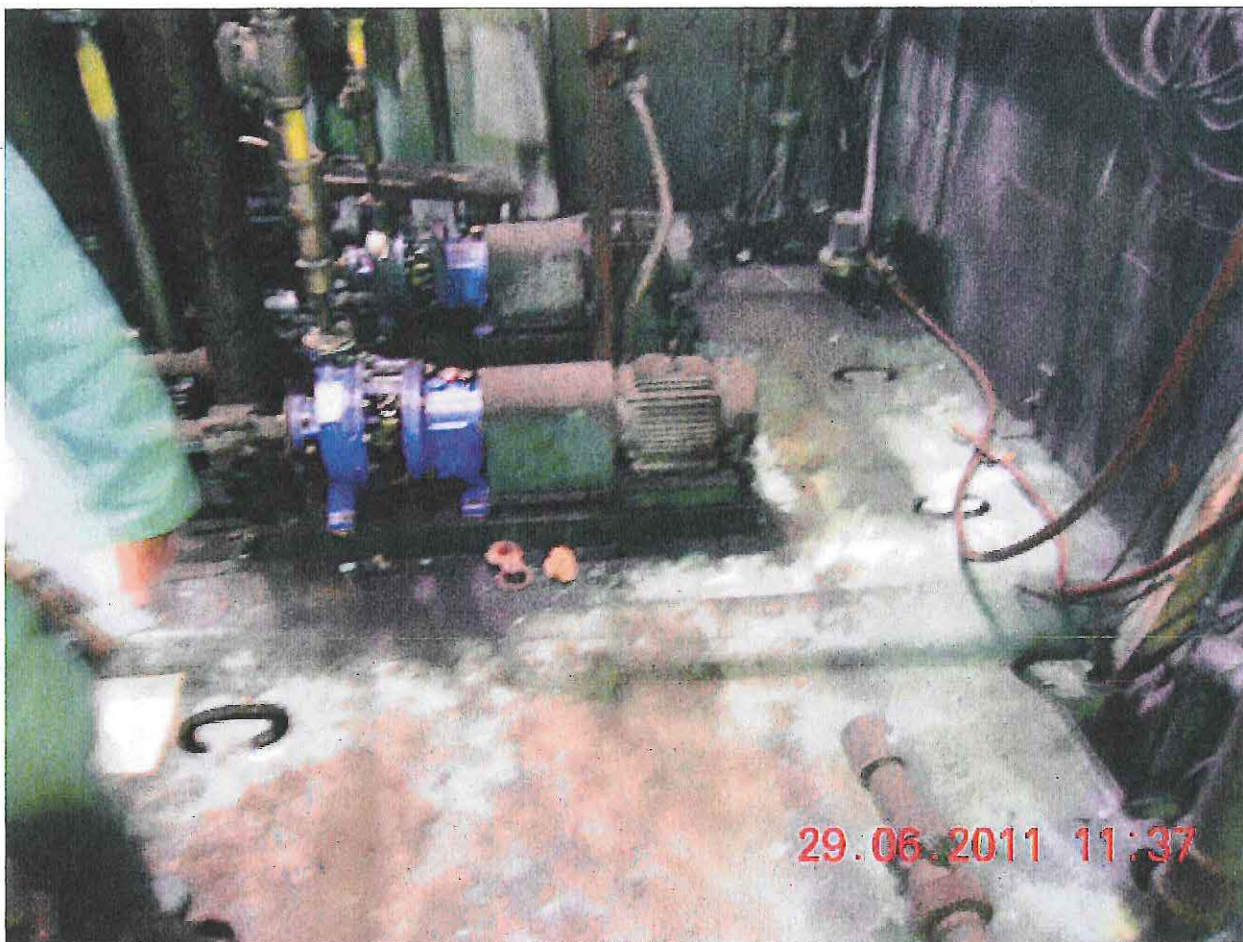
Facility: Arcelor Mittal, IND003913423
Location: 250 West US Highway 12, Burns Harbor, Indiana
Date: June 29, 2011, 11:37 a.m.
Photographer: Robert Dean Smith, LPG
Camera: Nikon Coolpix, 12.0 megapixels
Description: Photograph 59: Subbasement for phosphating area.

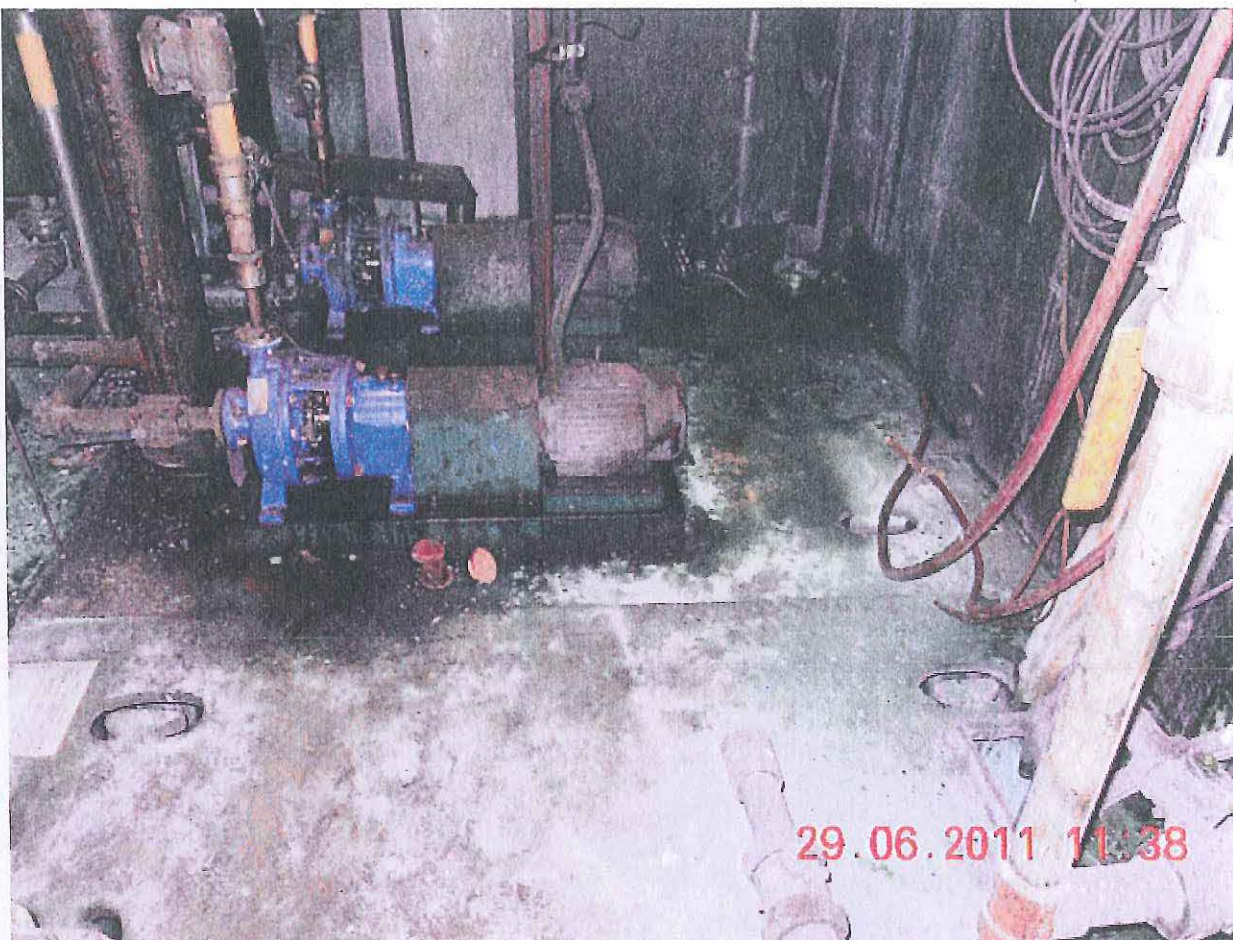
Facility: Arcelor Mittal, IND003913423
Location: 250 West US Highway 12, Burns Harbor, Indiana
Date: June 29, 2011, 11:38 a.m.
Photographer: Robert Dean Smith, LPG
Camera: Nikon Coolpix, 12.0 megapixels
Description: Photograph 60: Subbasement, phosphating area.
